A Method of Section Replacement for Pile-Bent Pier Rehabilitation

Abstract. This paper presents a case of repair practice for a concrete bridge that was classified as imminent failure condition. The bridge is slab-type with an equal span of 10 meters long. Each pier is built up of six driven concrete piles. Over 30 years, critical deterioration occurred to concrete pier columns with many severe corrosion spots on reinforcing bars. A concept of section replacement was used to develop a repair technique to remove an entire body of deteriorated materials and restore with selected new materials, was used to develop a repair method. The method involved several stages of works that included: site investigation, damage inspections; work area preparation and installation of temporary structure; material replacement; and work completion. The lesson learned from repair practice suggests the number of key success factors that are needed to complete the task safely.

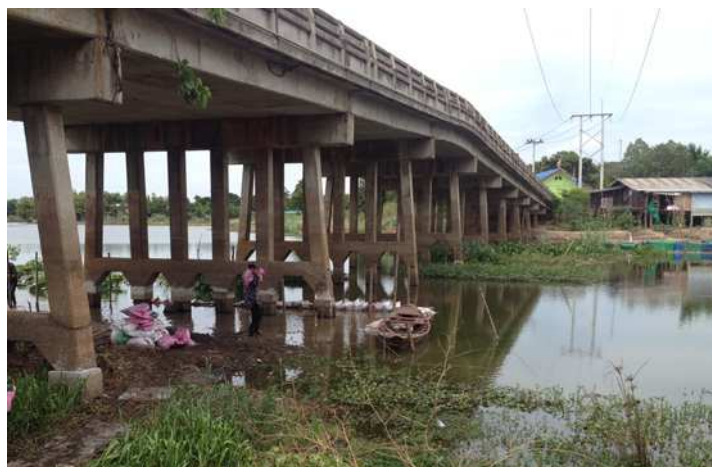
The bridge in this case study is located in a central region province. A photograph is shown in figure 1. It is 8 m wide and 130 m long, supported by 14 piers on an equal distance of 10 m pier-to-pier. All piers and upper column have the same cross-section size of 400x400 mm.

Figure 1. Photograph of bridge and site condition
